Saildrive Shaft Servicing

Hank, s/v Flash, 2001 C471, H#29

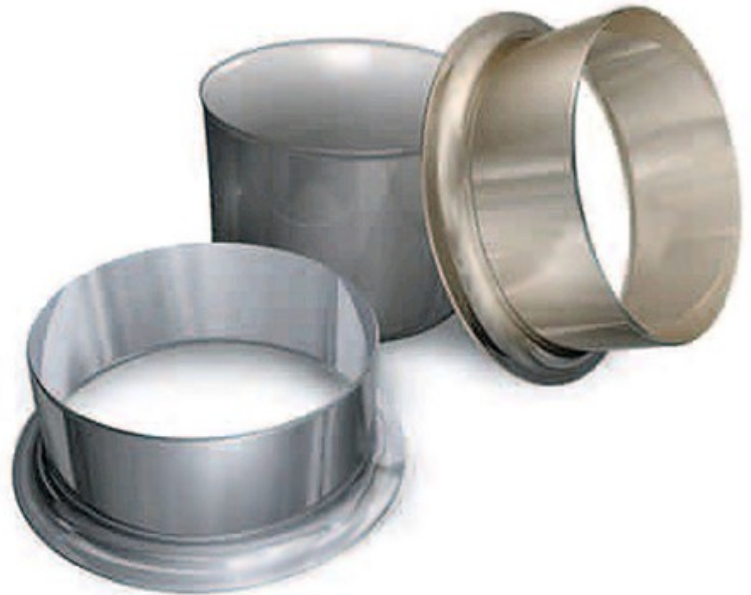
SpeediSleeve is a stainless steel product that comes in numerous sizes. I measured my shaft diameter and found the size SpeediSleeve specified to cover that diameter. For reference the Speedi Sleeve part number I found appropriate for my shafts was #99125. That is probably the size for other 471's with an S120 saildrive, but you should check to be sure. SpeediSleeves are made in a full range of sizes, so they can cover all size shafts. You'll need to measure your shaft diameter with digital calipers before ordering sleeves. SpeediSleeve comes with a metal cup shown in the above picture to help drive on the sleeve. However, it is not long enough for our application, and you'll need to use a longer tubing section that fits over the sleeve and against the SpeediSleeve collar.

The #99125 size fits shafts of 1.247 in. to 1.253 in. The SpeediSleeve is sized slightly smaller than this range, and the soft stainless steel stretches slightly when installed with an interference fit. I use Loctite blue on the

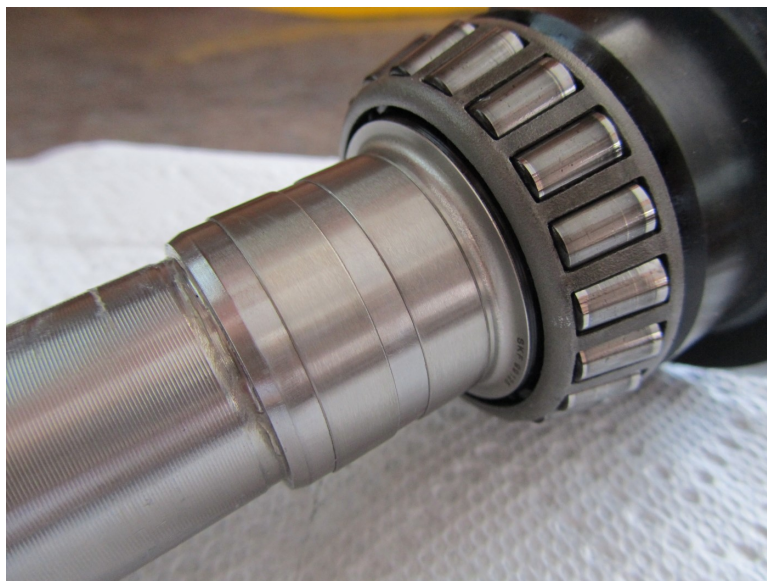
Repaired shaft with 2 SpeediSleeves,

shaft when sliding the SpeediSleeve in place to make sure I have a good seal under the sleeve. The sleeve is driven on using a piece of tubing just slightly larger than the sleeve, using a press or a mallet and block of wood. The tubing rides against a small, rolled collar on the end of the sleeve when driving onto the shaft. After the sleeve is placed carefully in the right location, the collar is peeled off, tearing away at a machined groove in the sleeve. This leaves a smooth sleeve over the damaged shaft area for the seal to ride on.

In our case with two seals, you will need to install two SpeediSleeves, one in the area of the shaft where each seal rides. This size SpeediSleeve is about 5/16 in. width when finished – not wide

enough to cover both locations of our seals.

For the S120 saildrive shaft, the first sleeve installed can be pushed all the way up against the gear, with the rolled collar going on first. Once in this location, you can leave the collar on this first sleeve. It is out of the way and helps position the sleeve in the right place. The second sleeve can then be slid into place at the proper location, and the collar removed. Measure carefully where the sleeves need to be placed before installation. You'll want to get the sleeve centered as best you can over the damaged area.
